US Army Corps  
of Engineers®  
Engineer Research and  
Development Center

## **Periodic Inspections of Hilo, Kahului, Laupahoehoe, and Nawiliwili Breakwaters, Hawaii**

Armor Unit Monitoring for Period 2001-2005

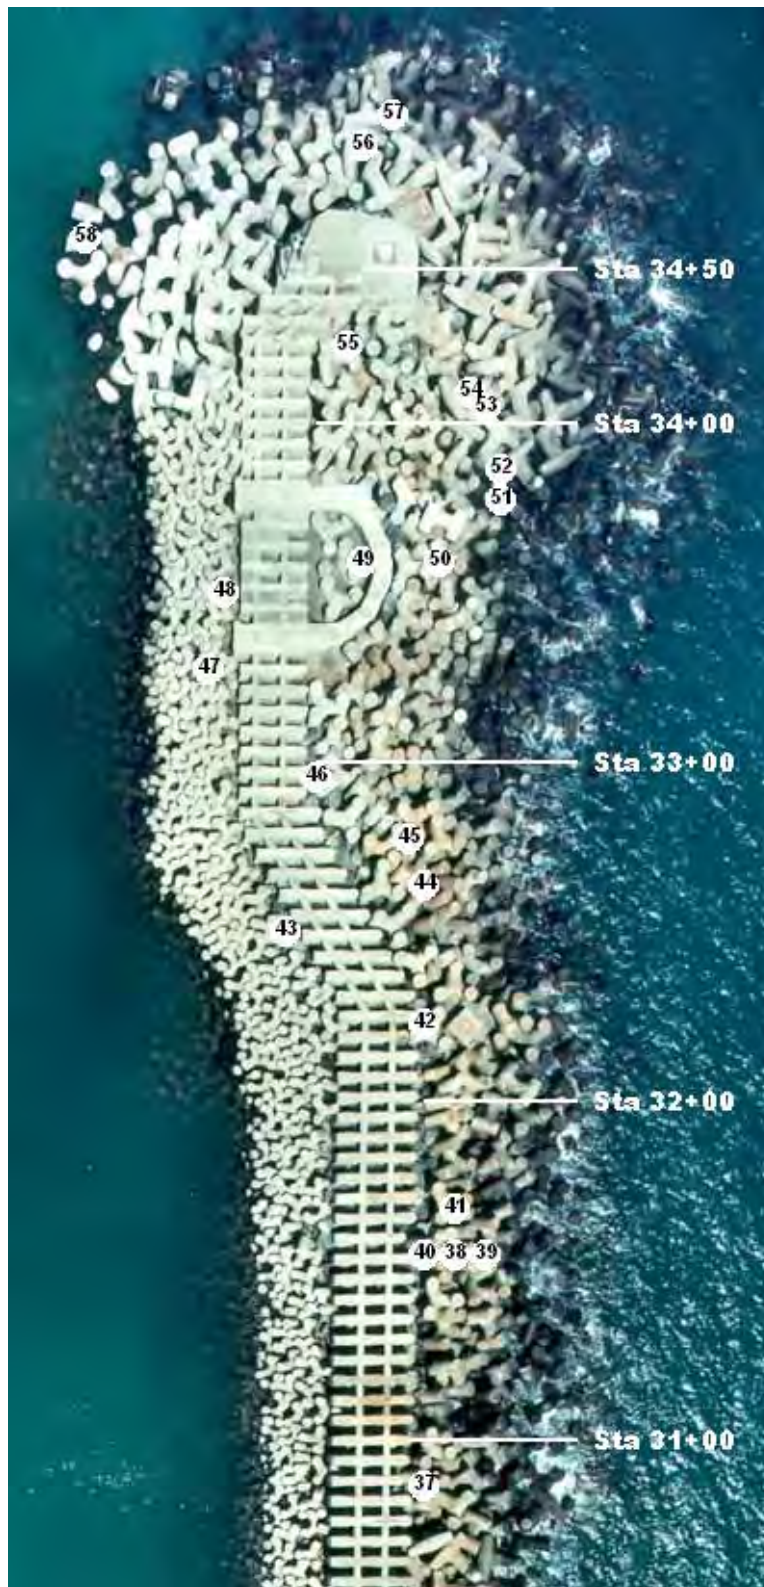
The 2005 walking inspection of the Kahului breakwaters identified such breakwater damage as broken/cracked armor units, displaced stones, settling, and voids. Deficiencies were photographed and approximate locations relative to stations were noted. Detailed information regarding these deficiencies can be found in inspection notes of Appendix B. Figures 31 and 32 show the approximate damage locations for the Kahului East Breakwater, and Figures 33 and 34 identify approximate damage locations for the Kahului West Breakwater. Aerial photograph location numbers correspond to numbers in the notes and photographs found in Appendix B.

Figure 31. Approximate damage locations on Kahului East Breakwater, photograph 1.

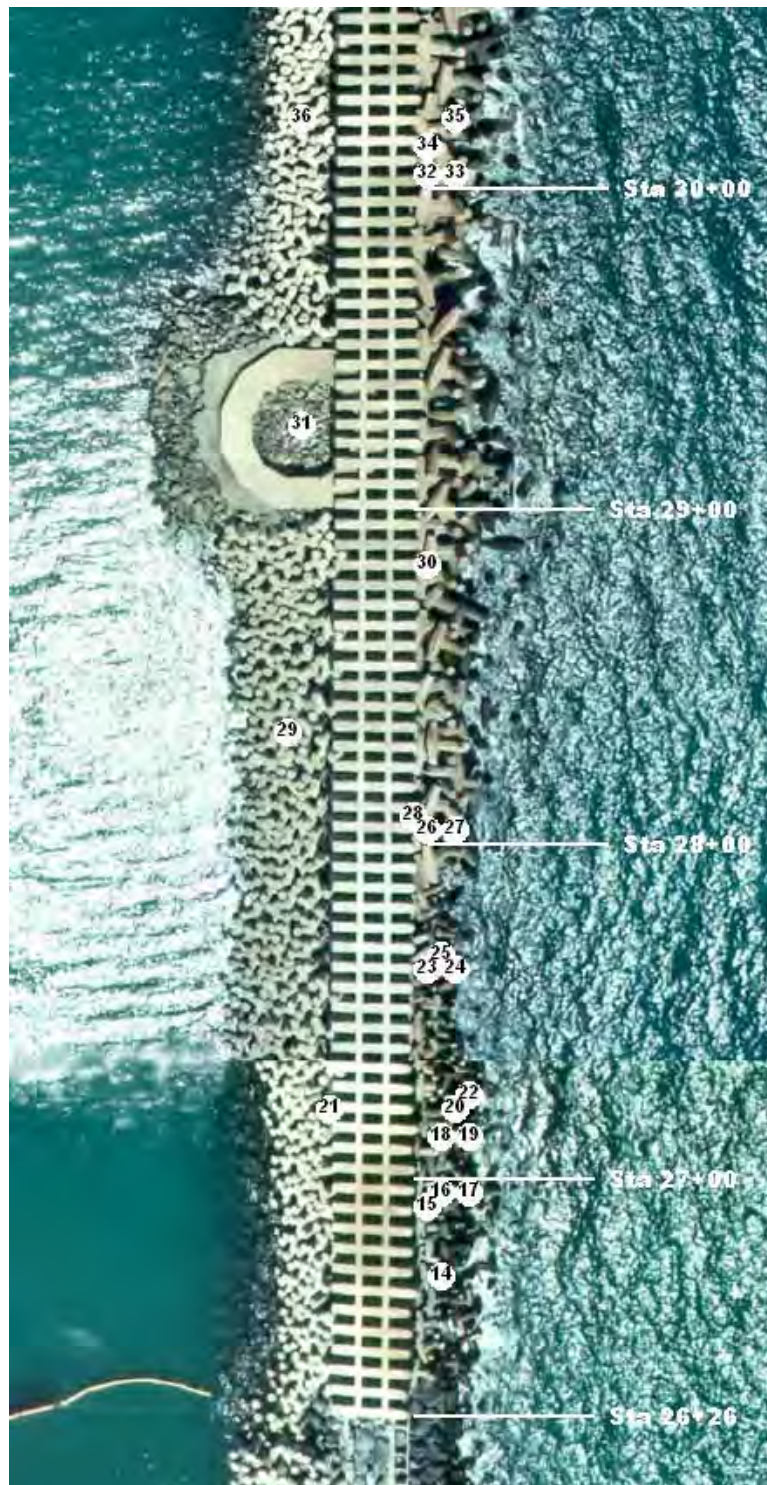
Figure 32. Approximate damage locations on Kahului East Breakwater, photograph 2.

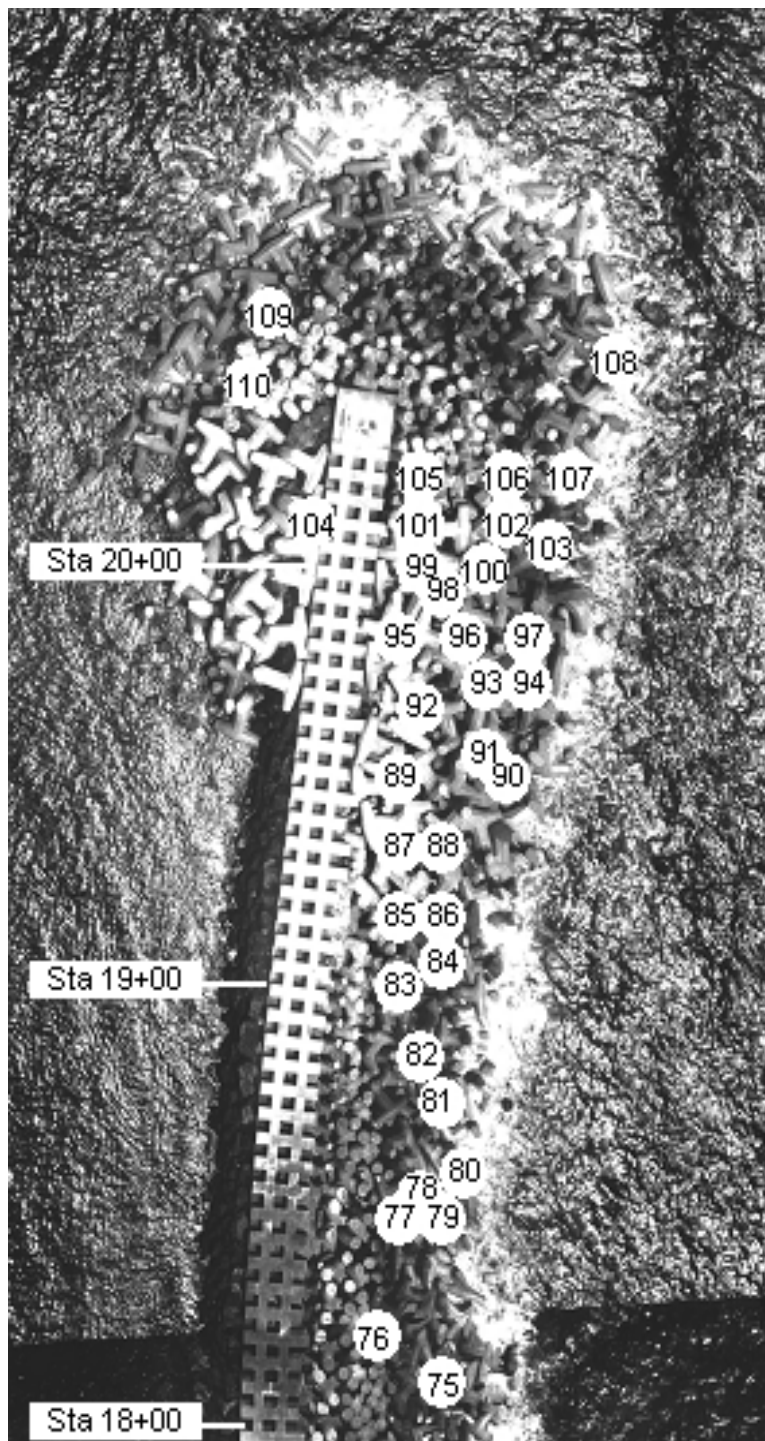
Figure 35. Approximate damage locations on Nawiliwili breakwater, photograph 1.

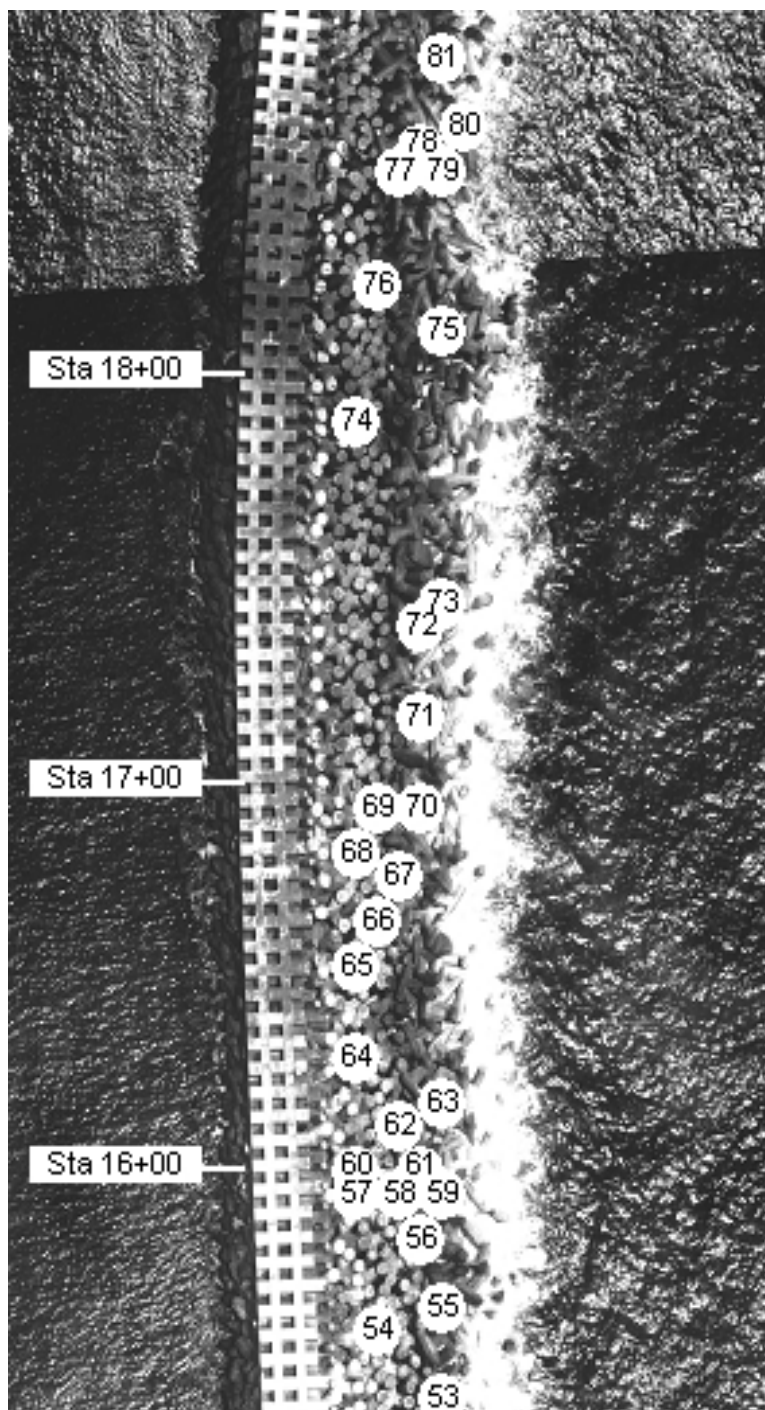
Figure 36. Approximate damage locations on Nawiliwili breakwater, photograph 2.

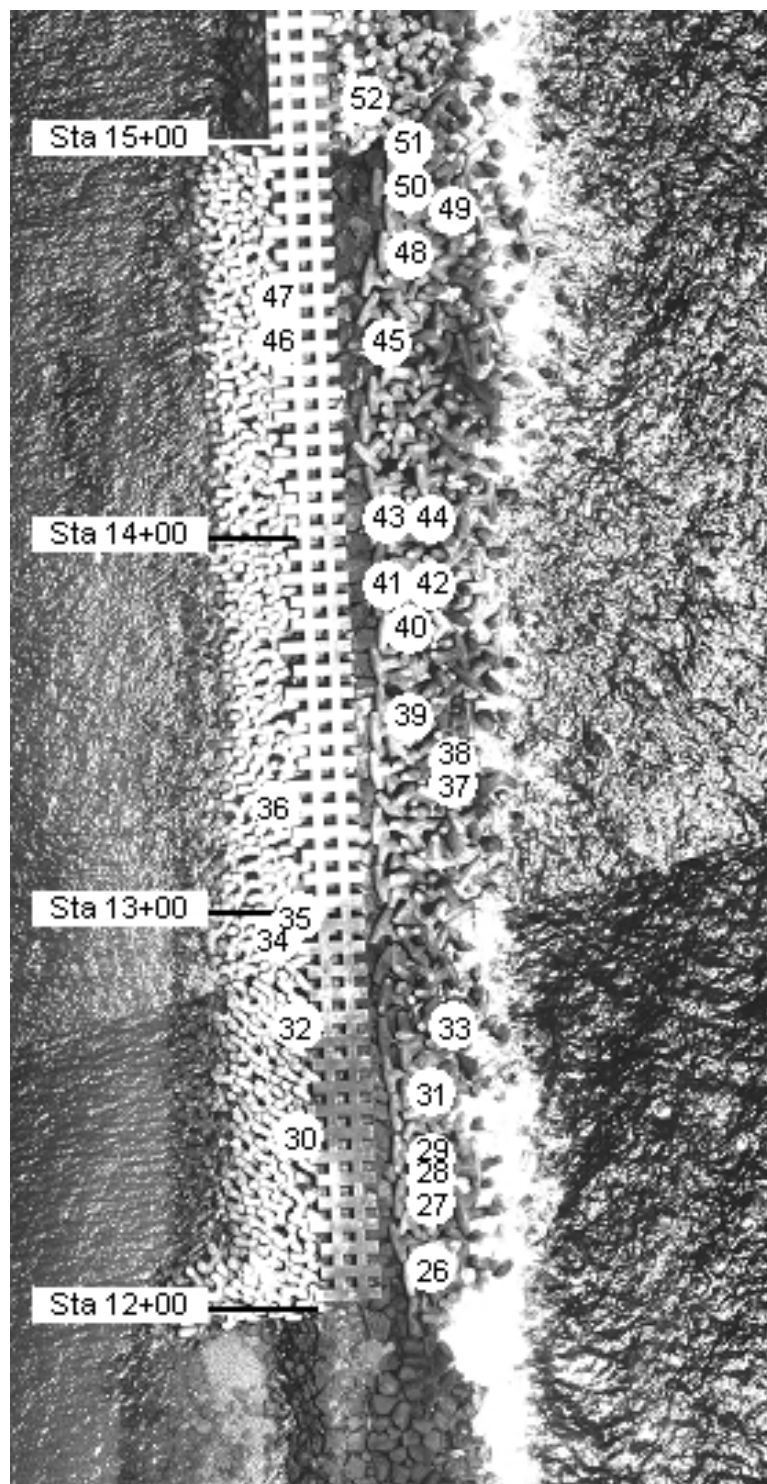
Figure 37. Approximate damage locations on Nawiliwili breakwater, photograph 3.

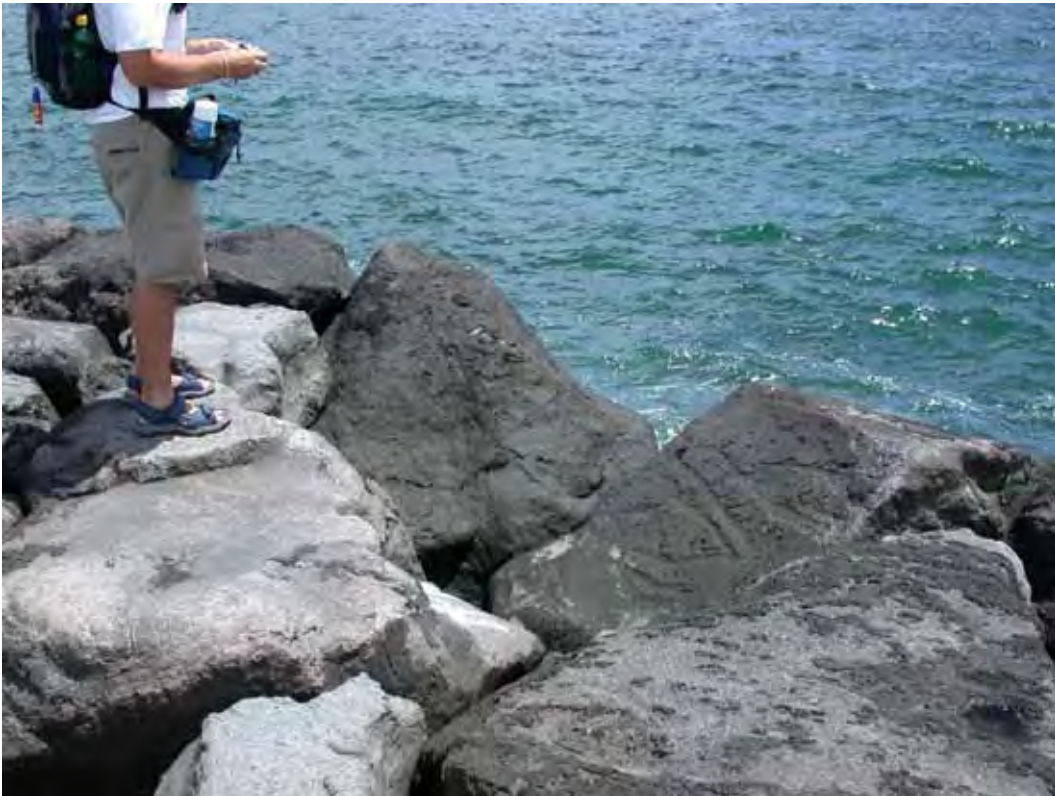
Figure A5. Damage location 4, sta 9+08, ocean side, void.

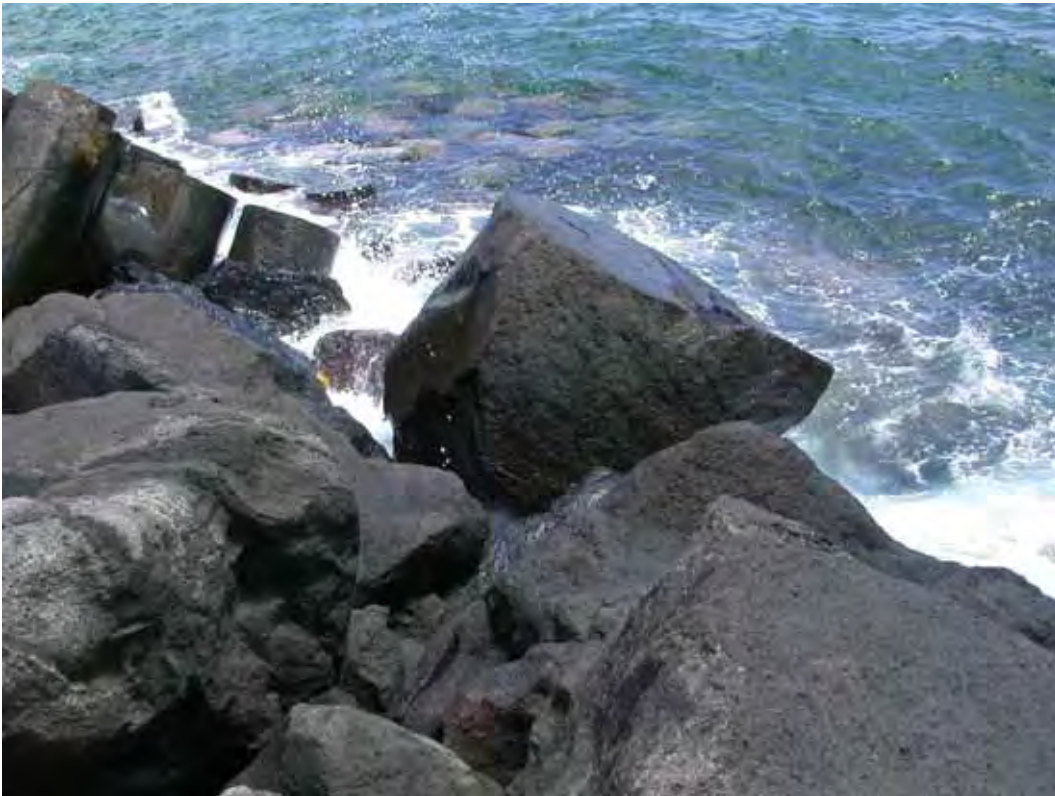
Figure A7. Damage location 6, sta 10+80, ocean side, dislodged stone.

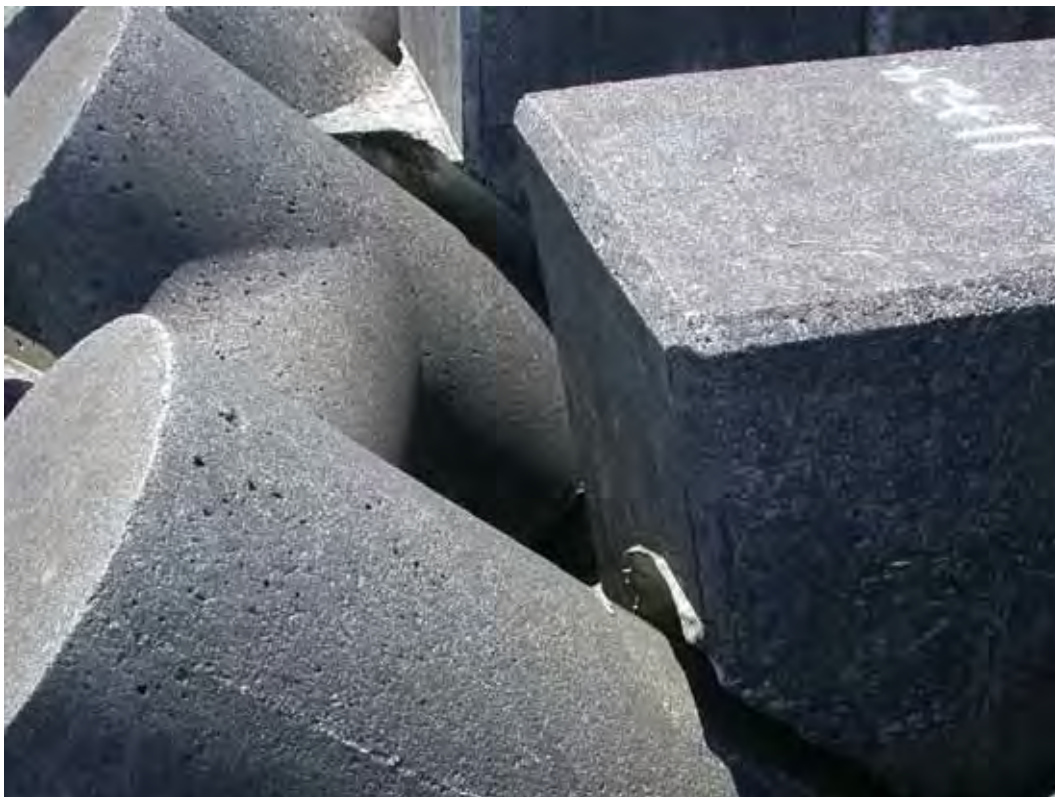
Figure A10. Damage location 9, sta 11+24, tribar separating from rib cap.

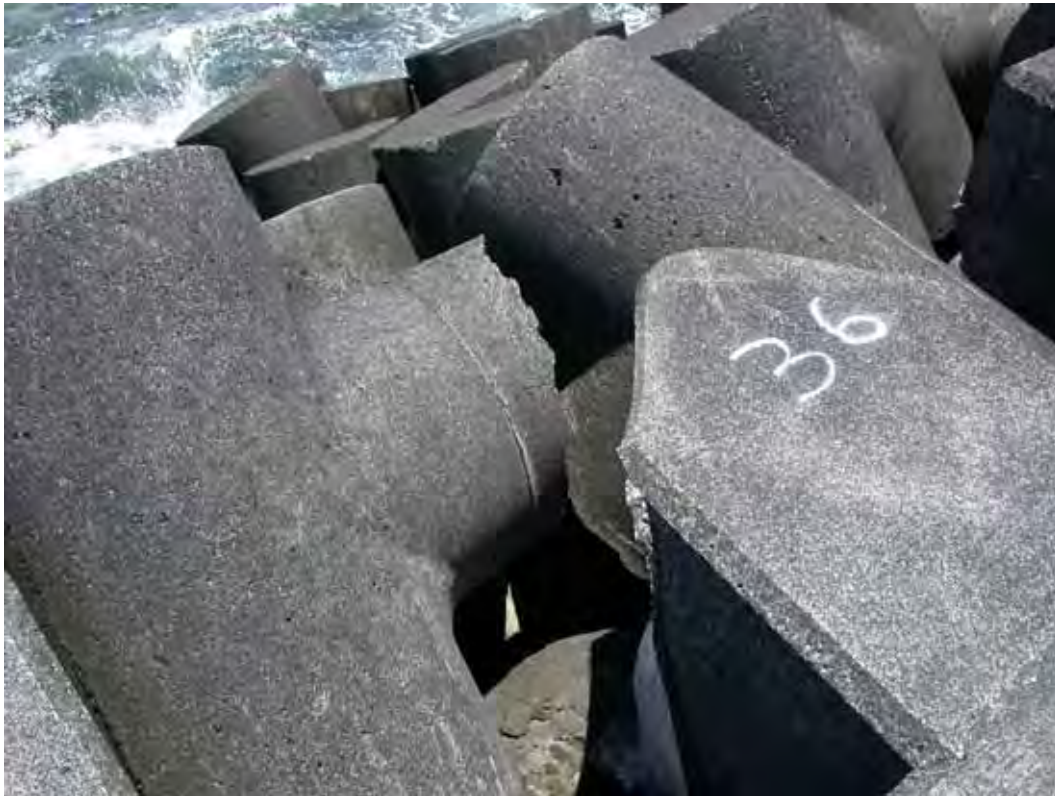
Figure A11. Damage location 13, sta 13+10, ocean side, rib #36, tribar with broken leg.

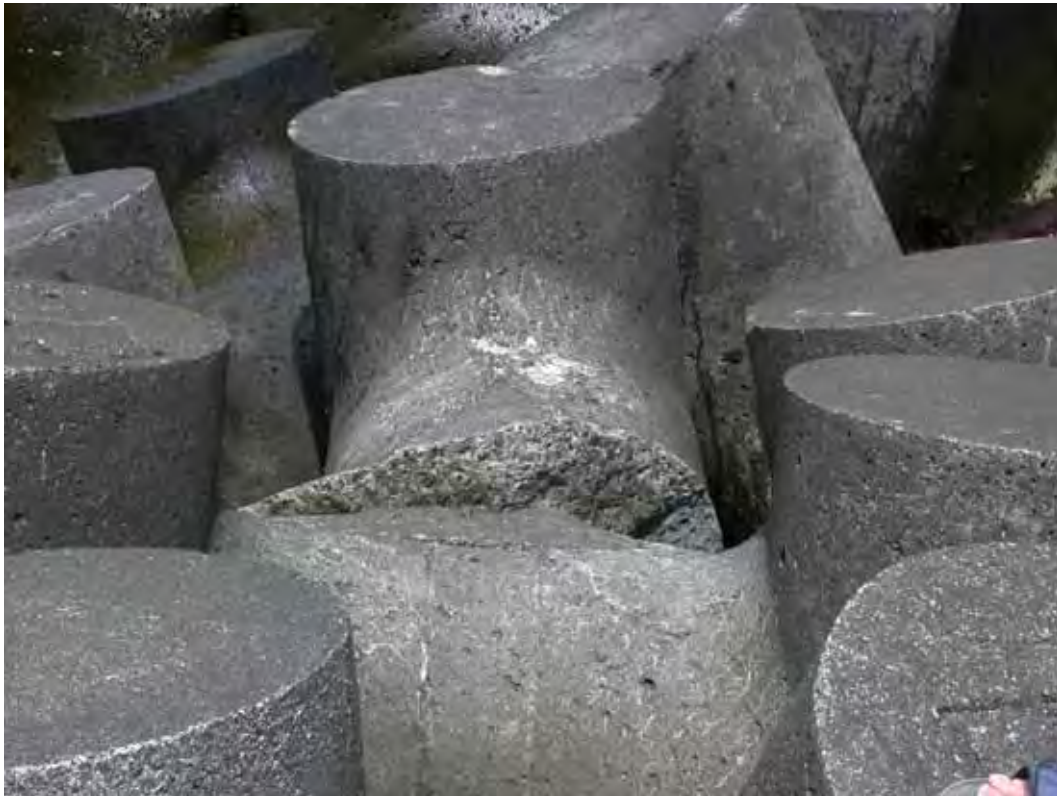
Figure A13. Damage location 15, sta 16+00, rib #85, tribar broken through center.

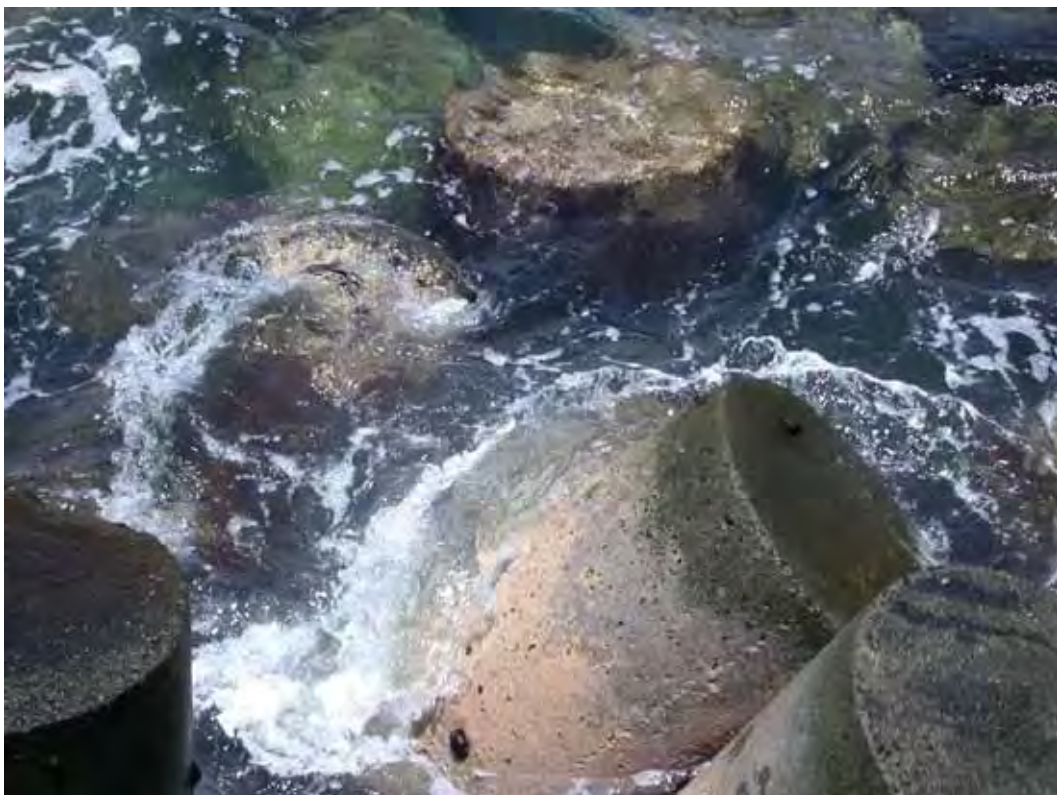
Figure A14. Damage location 16, sta 17+40, ocean side, broken tribar at waterline.

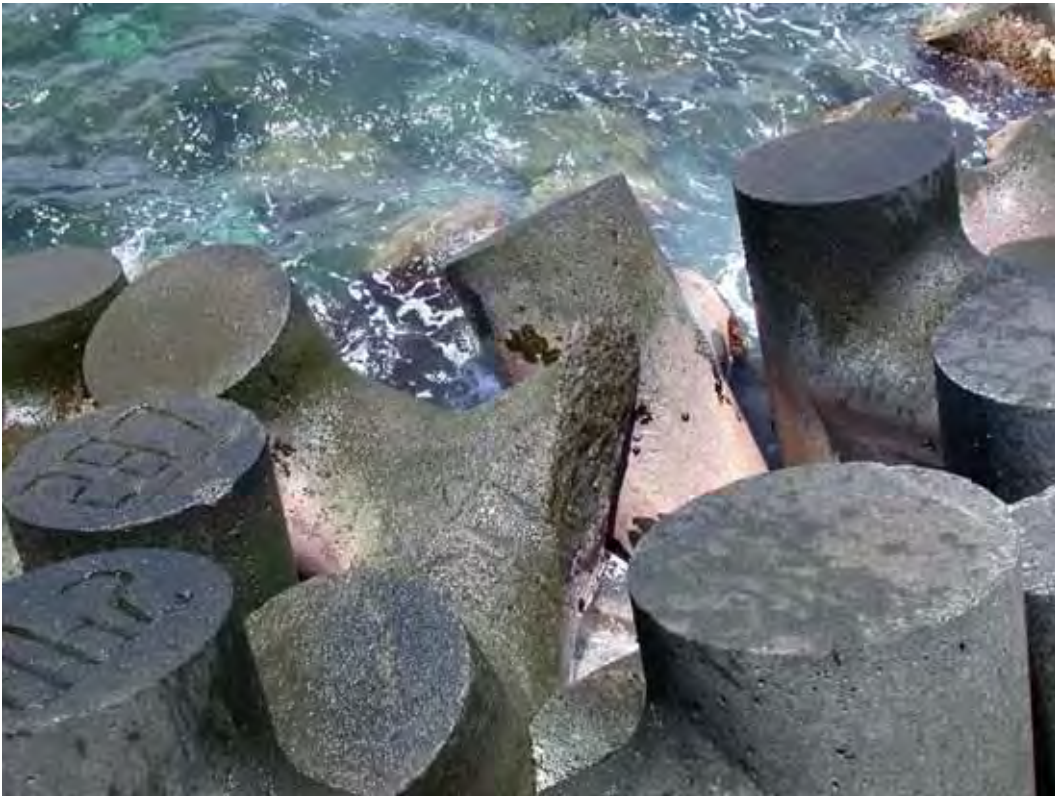
Figure A15. Damage location 16, sta 17+40, ocean side, broken tribar at waterline.

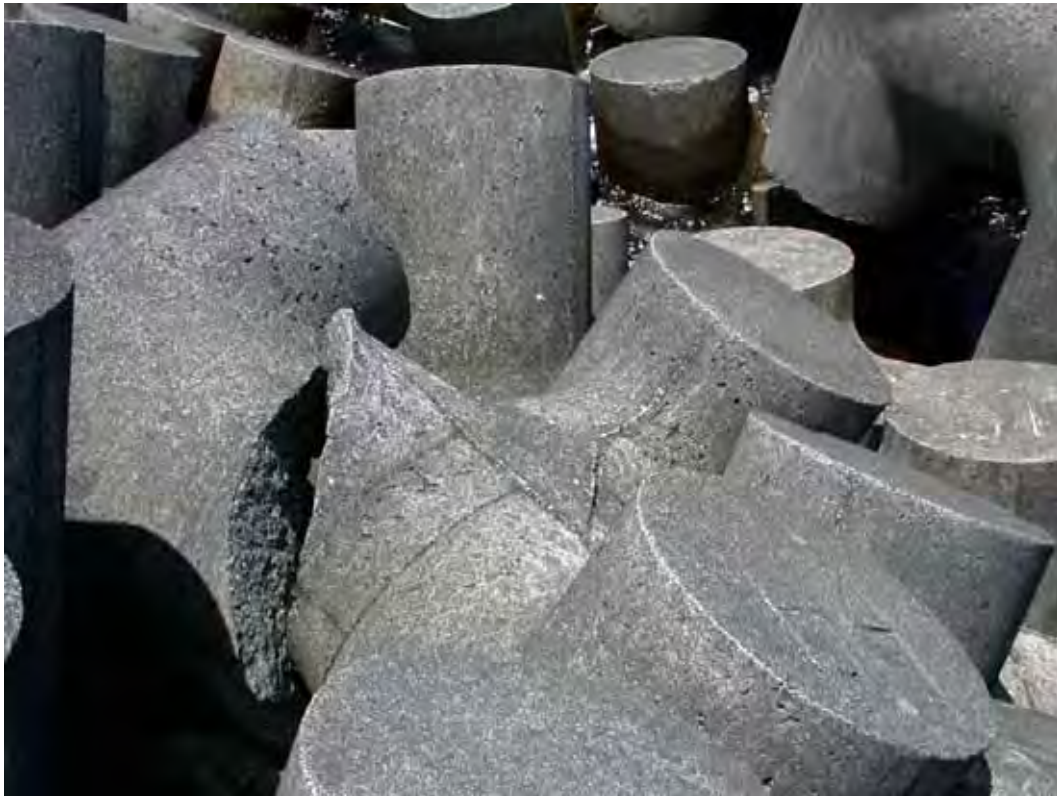
Figure A17. Damage location 17, sta 19+52, rib #143, tribar #64, broken leg.

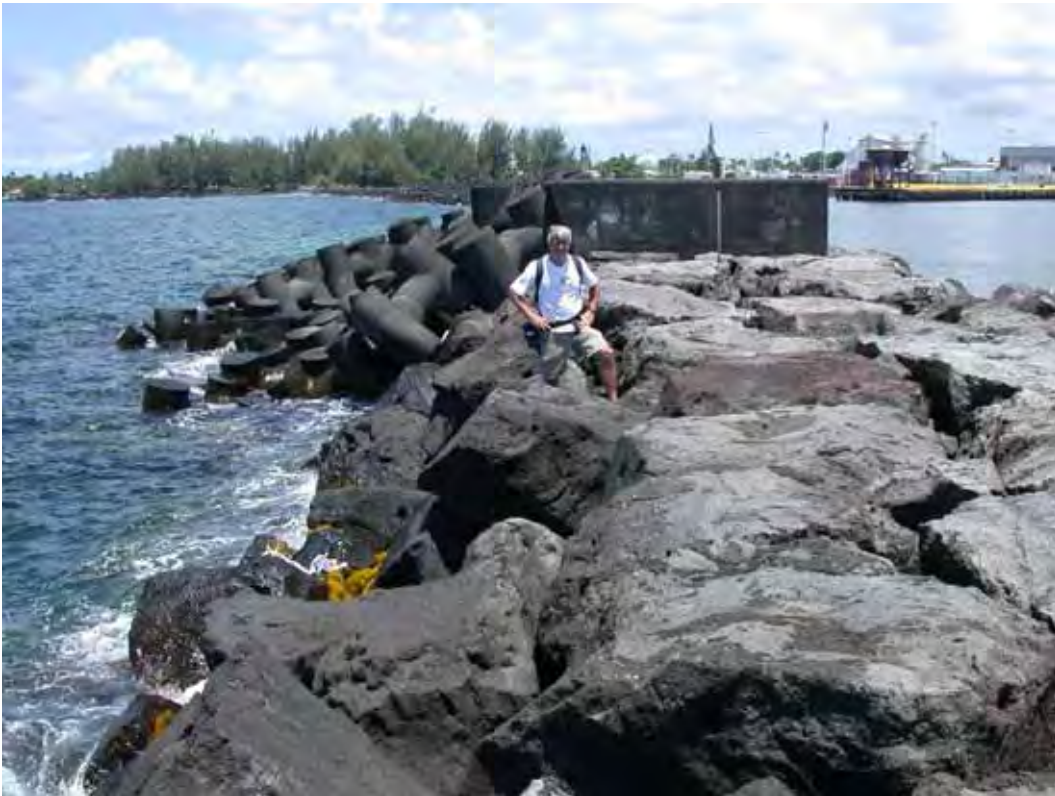
Figure A19. Damage location 18, sta 20+30, ocean side, void.

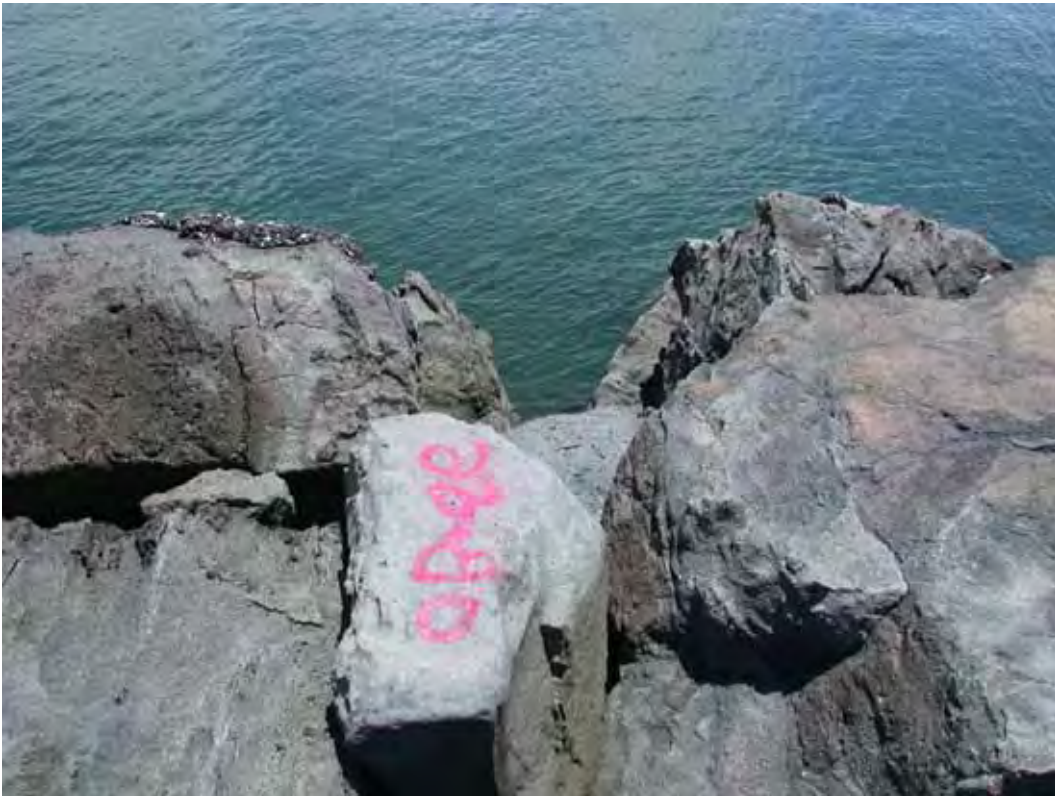
Figure A21. Damage location 20, sta 22+80, harbor side, missing armor stone at hinge.

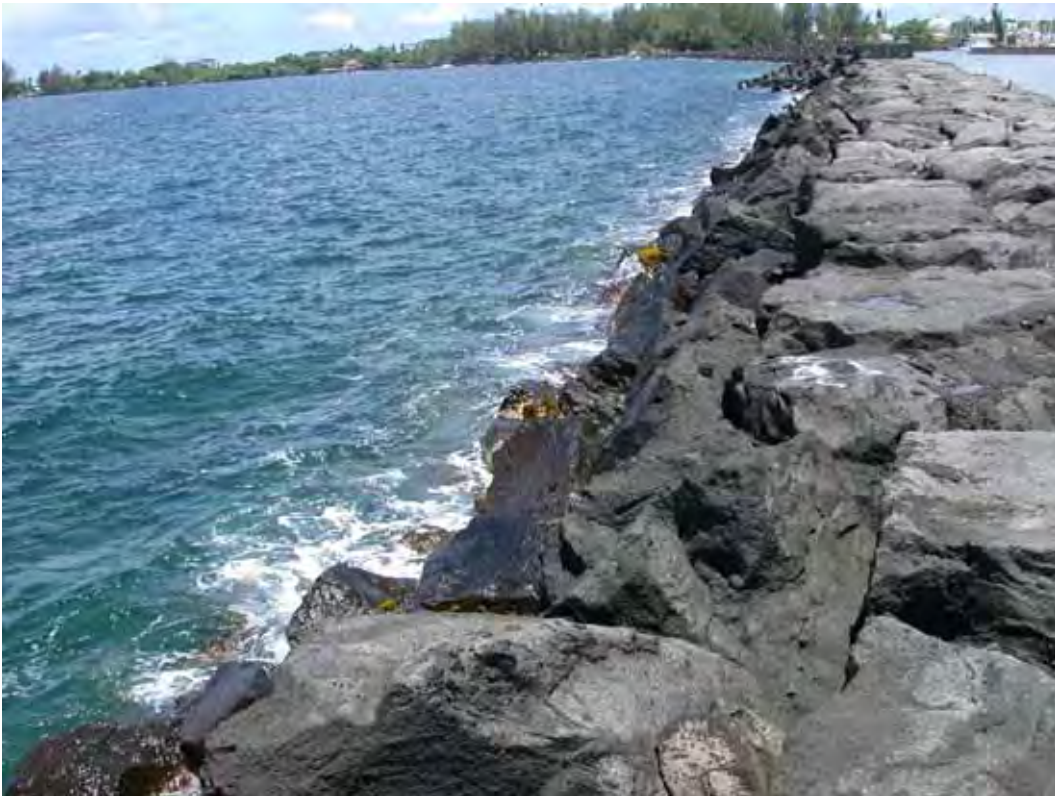
Figure A23. Damage location 22, sta 23 +40, ocean side, sharp drop.

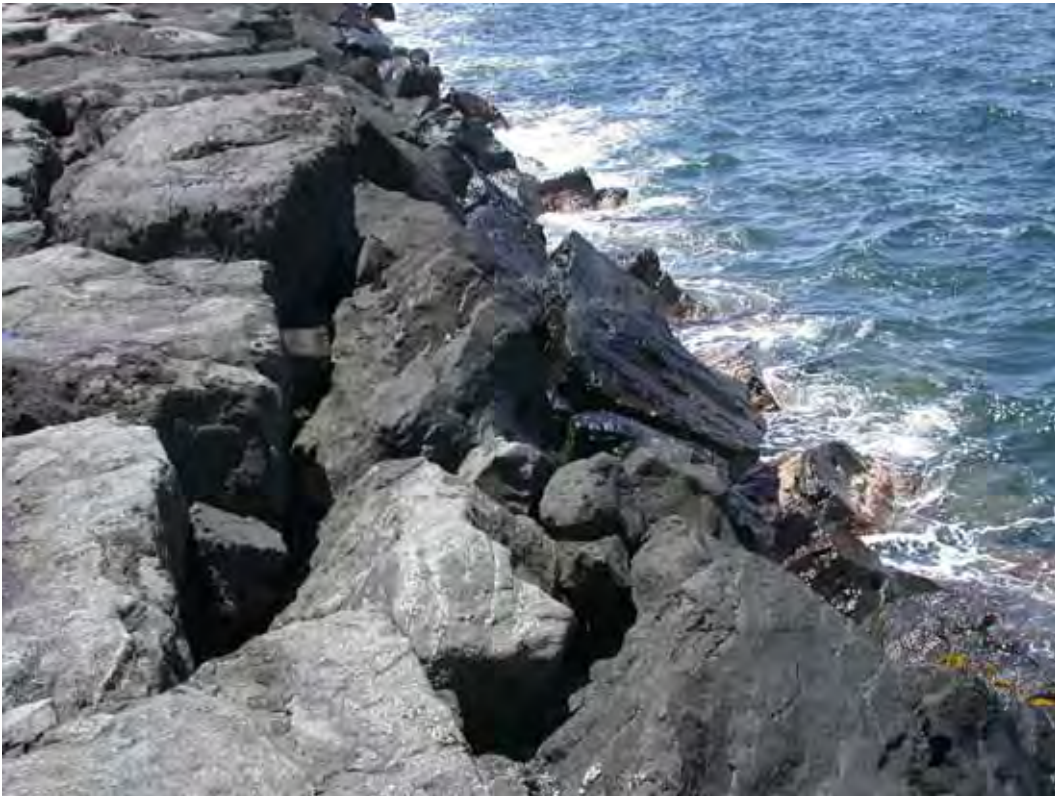
Figure A26. Damage location 25, sta 25+30, hinge stone separating.

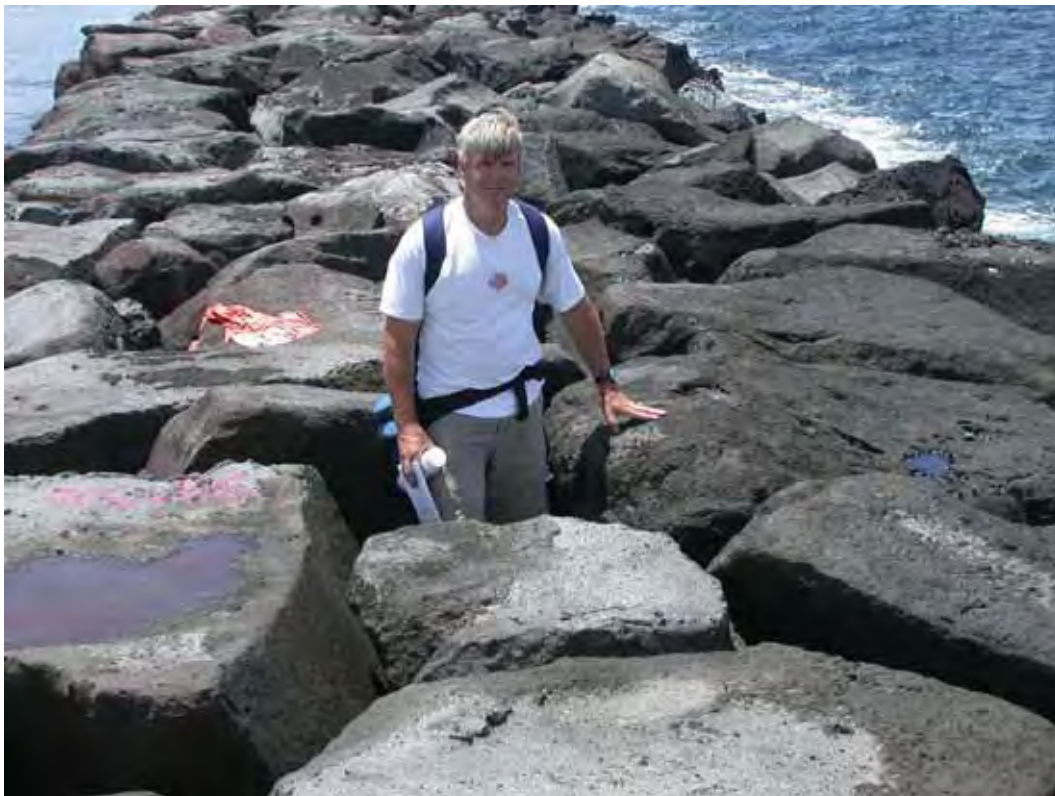
Figure A28. Damage location 27, sta 25+85, void at crest.

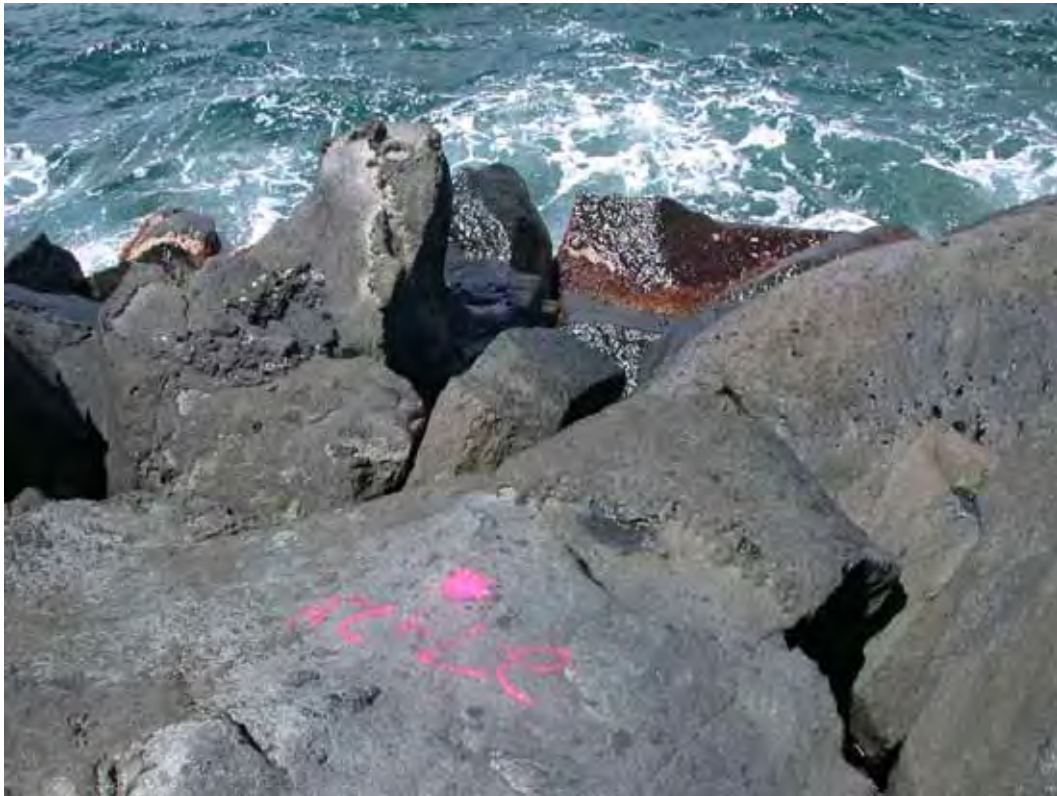
Figure A30. Damage location 30, sta 27+28, ocean side, hinge stone settling.

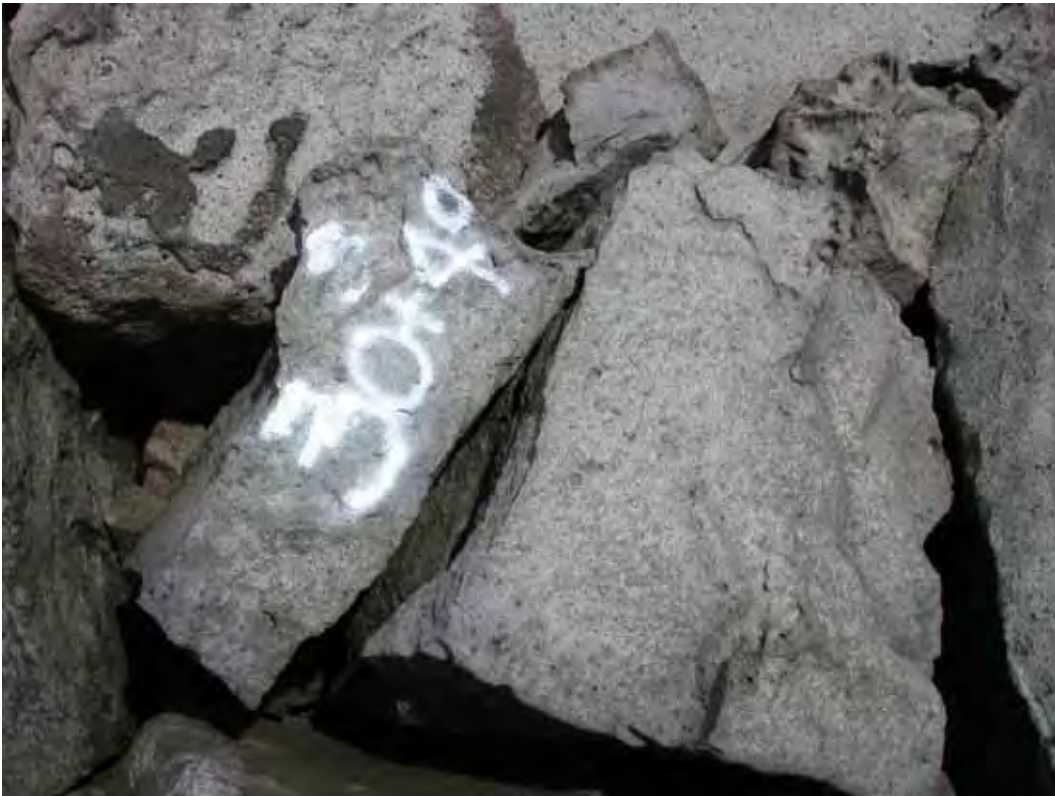
Figure A32. Damage location 34, sta 30+40, broken stone on crest.

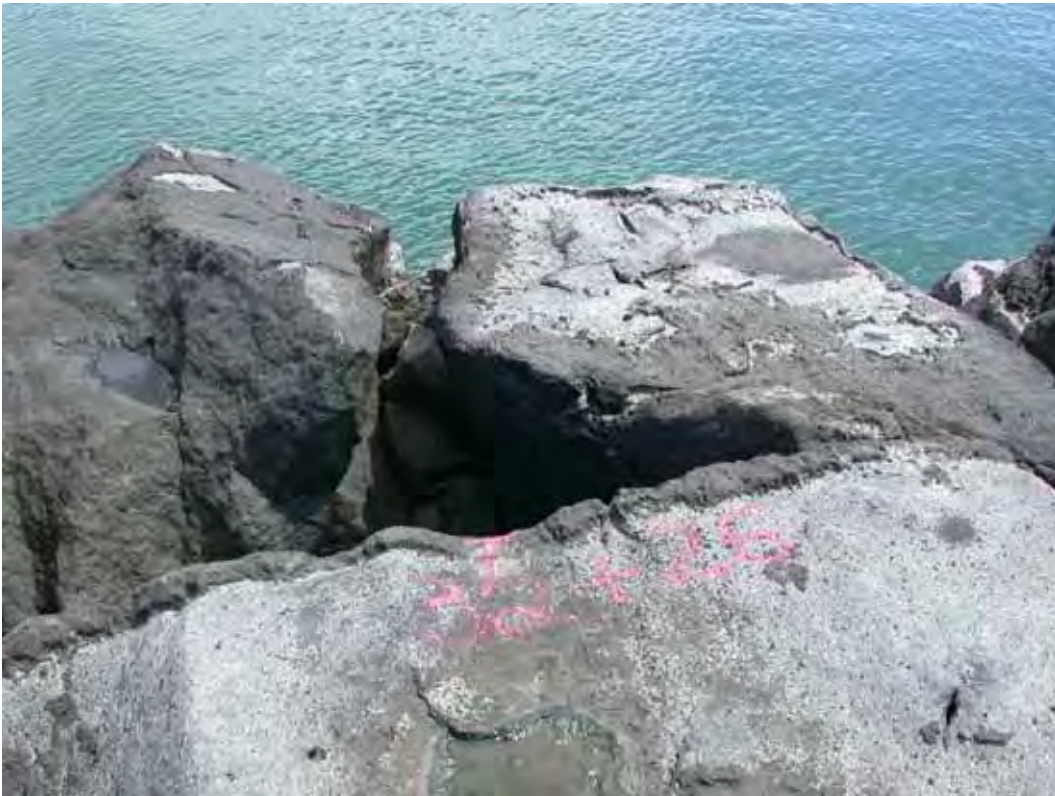
Figure A34. Damage location 36, sta 32+25, harbor side, void on edge of crest.

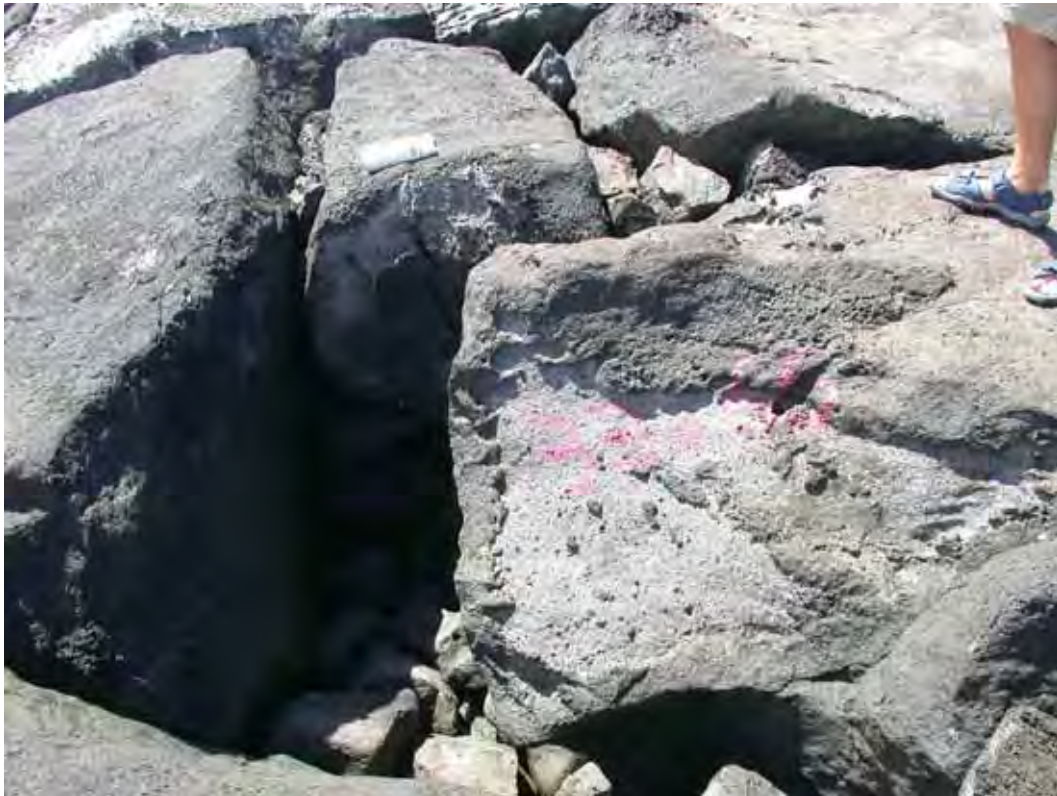
Figure A36. Damage location 38, sta 33+65, void at crest (3 ft x 6 ft x 4.5 ft).

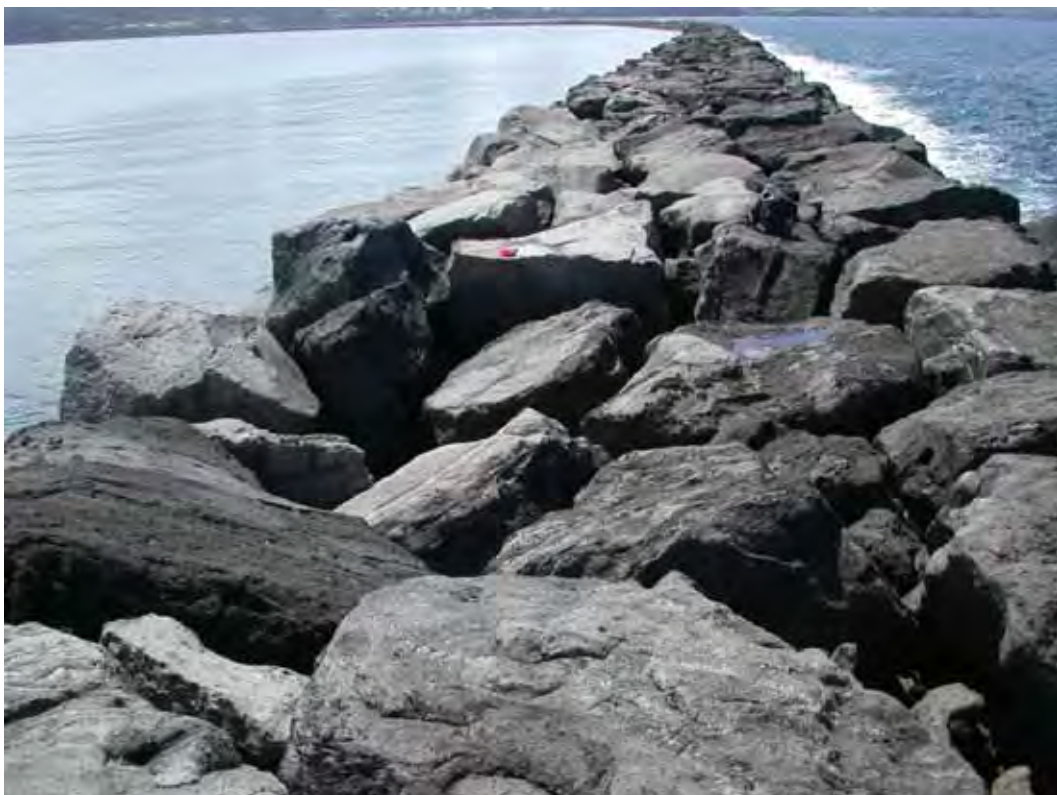
Figure A37. Damage location 39, sta 34+40, ocean side, settled hinge stone, void at crest.

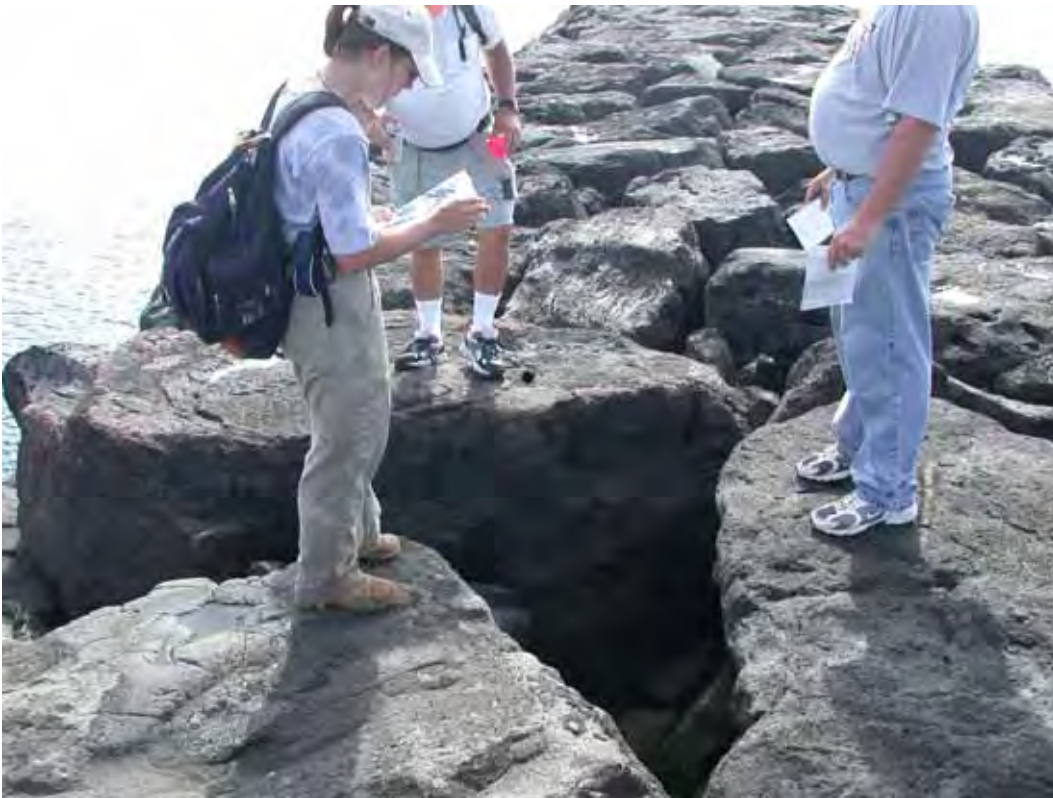
Figure A55. Damage location 59, sta 60+80, harbor side, void at crest (2 ft x 4 ft x 4 ft).

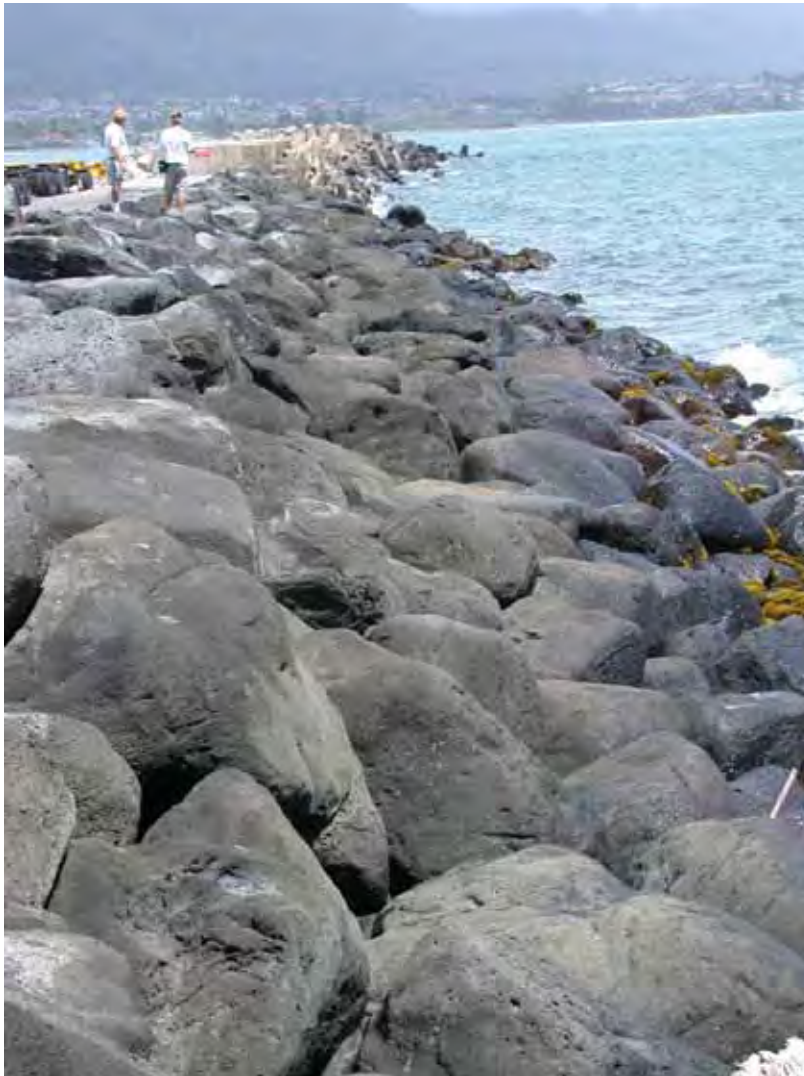
Figure B3. Damage location 8, sta 19+00-21+00, ocean side, side slope flattening.
